Report No. UT-12.03

## HEALTH MONITORING OF PRECAST BRIDGE DECK PANELS REINFORCED WITH GLASS FIBER REINFORCED POLYMER (GFRP) BARS

Utah Department of Transportation  
Research Division

University of Utah  
Department of Civil & Environmental  
Engineering

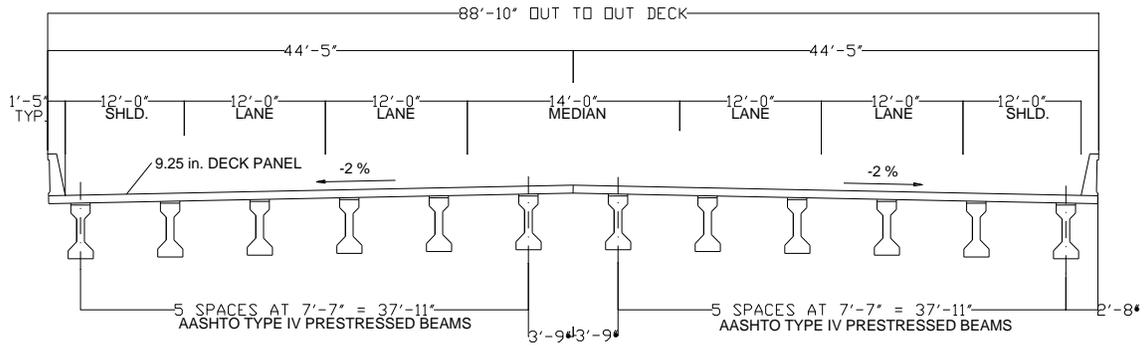
**Figure 3. Bridge cross section looking east**

approximately 33 thousand pounds (kips), as seen in Figures 3-5. The project focuses on Phase II of the Beaver Creek Bridge.

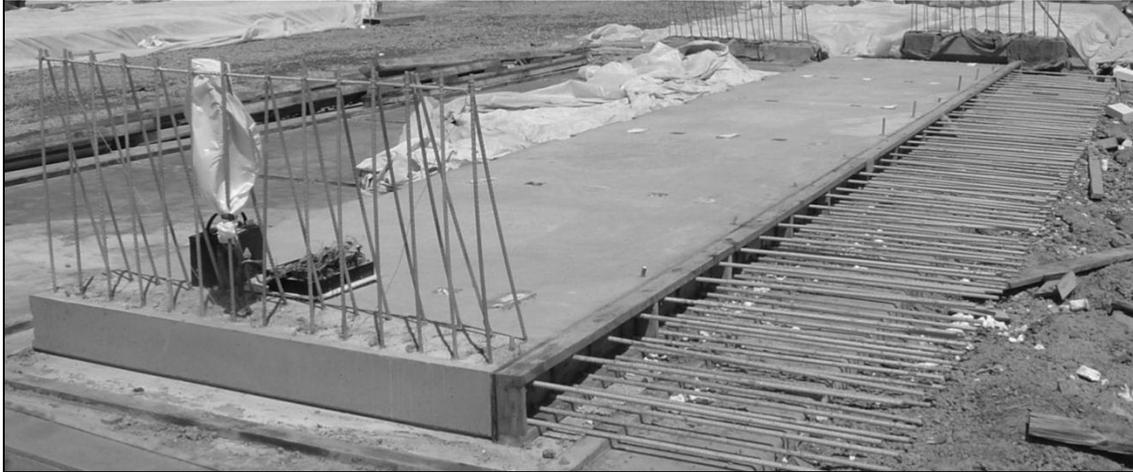
**Figure 5. Panel EP3 sitting in the precast yard with approach slab rebar to the right**

The 24 deck panels were fabricated in Pleasant Grove, Utah, transported 64 miles to the bridge site, and lifted into place. Each panel was lifted a total of 3 times before ending in its service position. During the first lift, the deck panel was removed from its formwork. This lift took place before the parapet had been cast. Once the parapet had been cast, the panel was placed on the bed of a tractor trailer. During the final lift, the panel was placed on the bridge girders.

2 panels were chosen for instrumentation due to their location on the bridge, End Panel Three (EP3) is located next to the west abutment of the bridge and Phase 2 Panel Five (P2-05) is located at the mid-span of the bridge, as shown in Figure 13. This project used 2 types of strain gauges for monitoring the strains inside the panels. Displacement sensors were also used for monitoring the performance of the panels, accelerometers were used to monitor peak accelerations of the bridge girders at midspan. Furthermore, 1 sensor was used to monitor the atmospheric conditions at the bridge site. In addition to the 5 sensors mentioned above, surveying equipment was employed to determine the midspan deflection of the girders during the static load test.

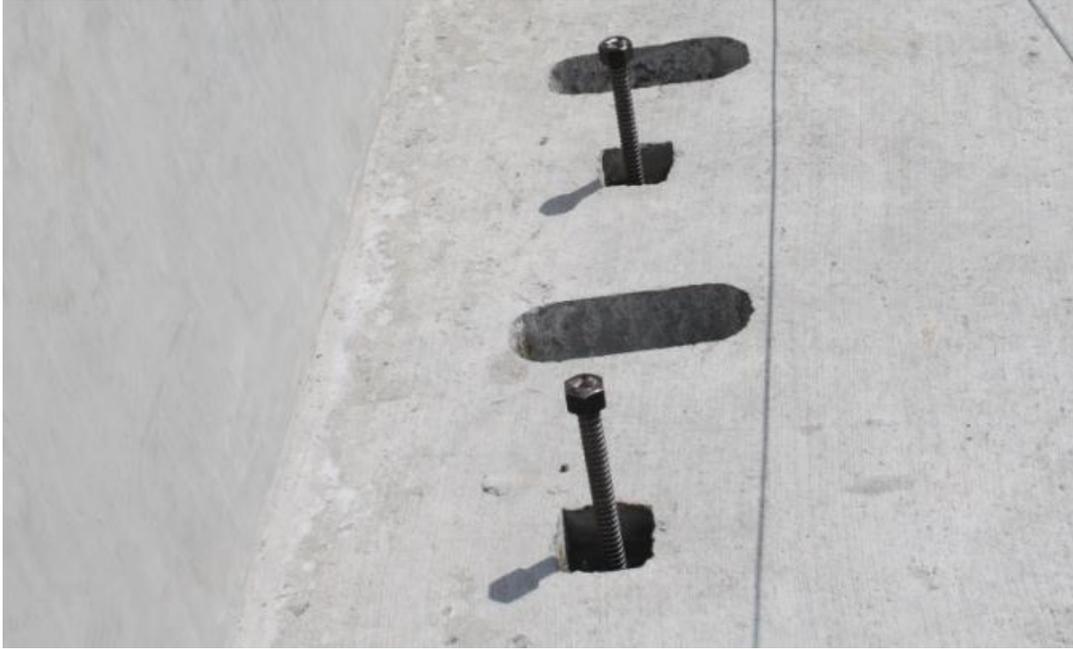
**Figure 6. Leveling bolts and shear stud blockouts**

Once the panels were in place, they were vertically adjusted using leveling bolts. Once adjusted, the panels were connected to the girders using shear studs and non-shrink grout in the shear stud blockouts to provide composite action with the girders, as seen in Figure 6. Finally, the 3-foot closure pour was cast to connect the 2 sets of panels, as shown in Figures 2 and 4. The deck panels were post-tensioned in the direction of traffic flow, to increase the shear transfer of the grout key between the panels, to reduce the potential for cracking, to close the joints and prevent future leaking. The stress intensity at which the post-tensioning strands were tensioned was only 40.8 kips as compared to the typical jacking force of 46.9 kips.

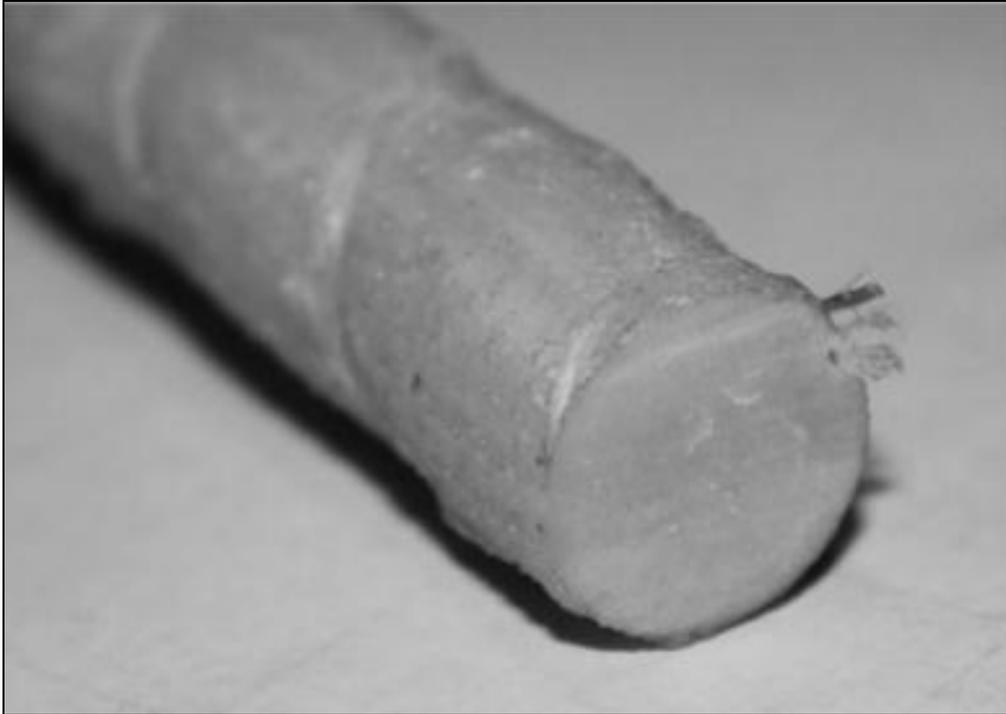
**Figure 7. Close-up of GFRP bar**

Glass Fiber Reinforced Polymer bars are a substitute for traditional steel reinforcement, and at the most basic level the material is similar to the fiberglass used widely today. GFRP bars are made from long strands of high strength E-glass, (alumino-borosilicate). The strands are bound together with S-glass (alumino silicate). The 2 types of glass fibers together with additives and fillers are combined with a vinyl ester resin in a pultrusion process to create the bars shown in Figure 7. This process is combined with an in-line coating process to obtain exterior adhesion properties (Tang, 1997).

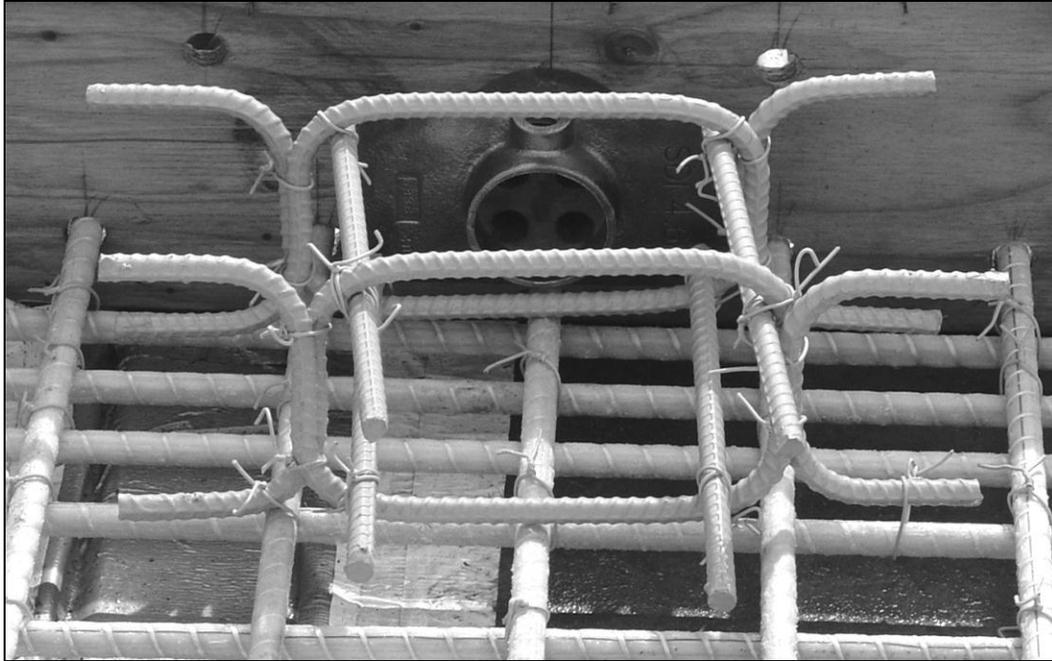
**Figure 8. Steel reinforcement to accommodate increased shear demand from post-tensioning anchor**

Moreover, the GFRP bars could not provide enough shear strength for post-tensioning stresses at the anchors. To compensate for this, supplementary steel reinforcement was used on the end panels to provide additional strength to the post-tensioning anchors and aid in stress distribution, as shown in Figure 8. Additionally, extra GFRP bars were used to reinforce the area around the post-tensioning anchors (Nix 2010).

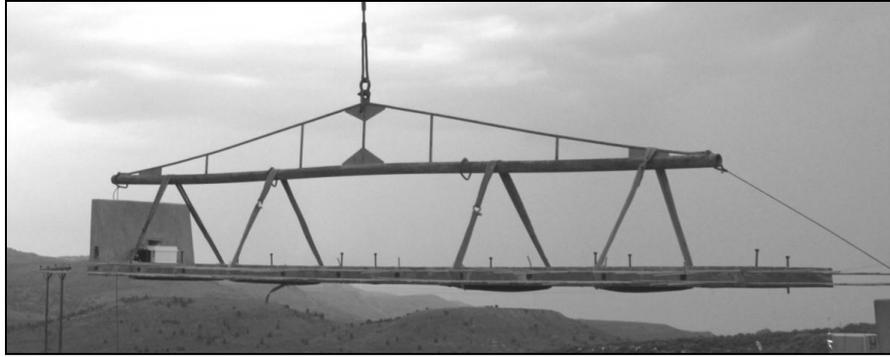
**Figure 9. Panel P2-05 being lifted using straps at the bridge site**

Due to the decreased elastic modulus of the GFRP bars, the deck had to be lifted using straps instead of embedded anchors as shown in Figure 9. Typically, embedded anchors are attached to the bars; due to the nature of the GFRP bars, the shear capacity of the bar was a concern in the lifting process. Therefore, the panels were lifted from below. For each lift, the panels were lifted at 4 points. Strap locations are shown in Figures 9-10. Figure 10 shows the Prestressed Concrete Institute (PCI) lifting points and the actual lifting points for 3 lifts.

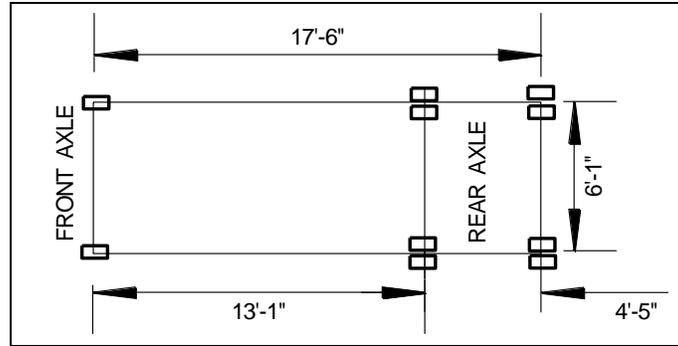
**Figure 11. Test truck dimensions**

Front axle	8000
1 <sup>st</sup> Rear axle	32000
2 <sup>nd</sup> Rear axle	32000
Gross WT	72000

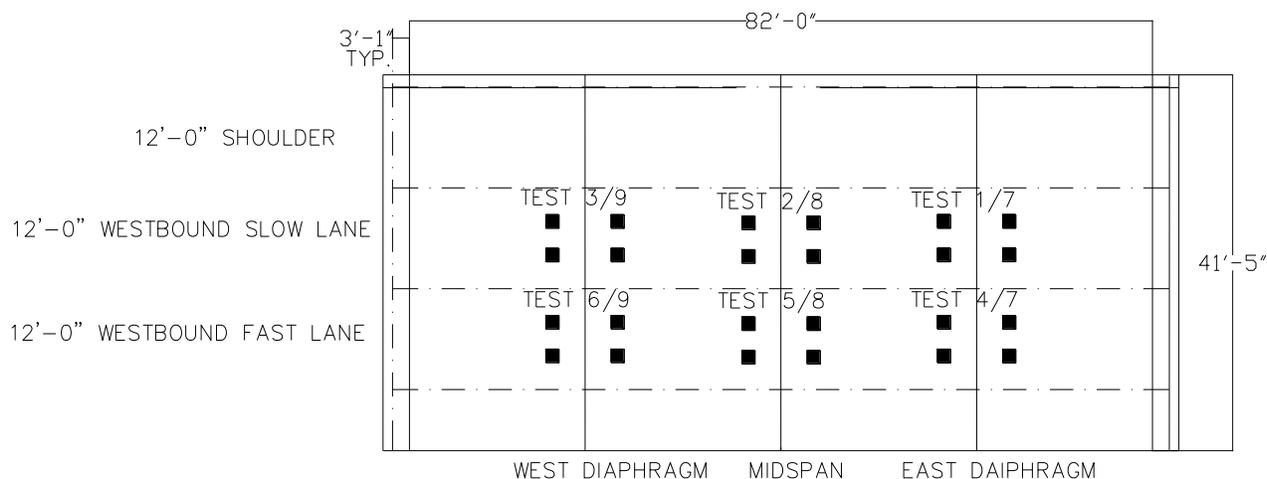
**Figure 12. Locations of trucks during truck load test**

Test #	Type of test	Lane Tested	Truck used	Rear Axle Position
1	Static	Slow	A	East Diaphragm
2	Static	Slow	A	Midspan
3	Static	Slow	A	West Diaphragm
4	Static	Fast	B	East Diaphragm
5	Static	Fast	B	Midspan
6	Static	Fast	B	West Diaphragm
7	Static	Both	A&B	East Diaphragm
8	Static	Both	A&B	Midspan
9	Static	Both	A&B	West Diaphragm

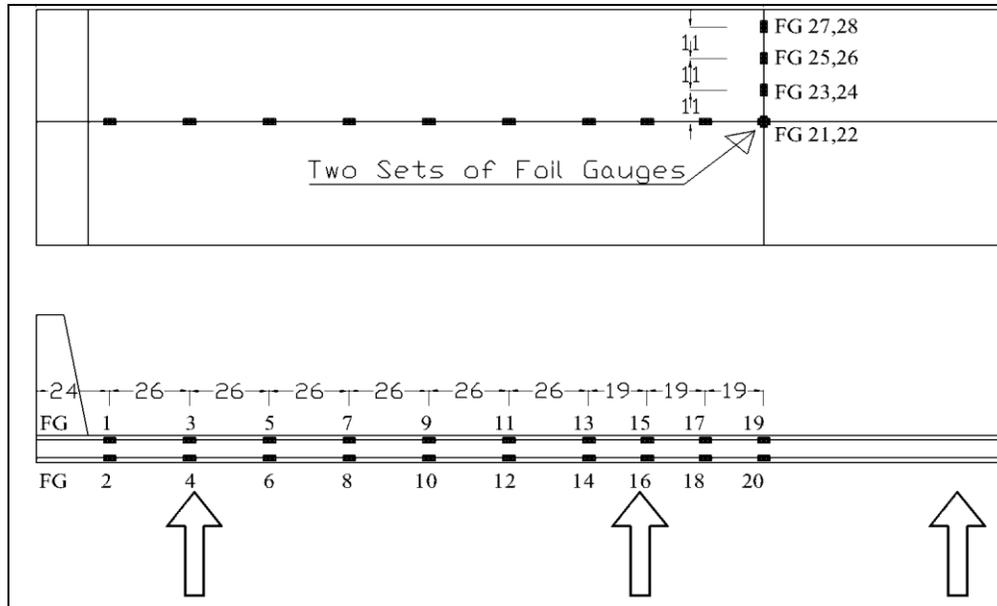
**Figure 14. Electrical gauge locations for both panels**

Each panel was instrumented with 28 electrical strain gauges, to be used during lifting and transportation of the panels. These gauges were attached directly to both the top and bottom GFRP mats and recorded the strains in the bars. Of the 28 gauges, 20 were placed in the transverse direction of the bridge (longitudinal direction of the panel) to record strains in the long dimension of the panel during lifting. The remaining 8 gauges were placed in the longitudinal direction of the bridge to record strains in the short dimension. Figure 14 provides a more detailed look at the locations of the gauges. Gauge locations were chosen due to their proximity to the lifting points and point of maximum theoretical moment. Electrical strain gauges were chosen due to their high sampling rate potential, relatively low cost, and overall simplicity. Drawbacks include difficulty in attaching them to GFRP bars, as well as their short life span.

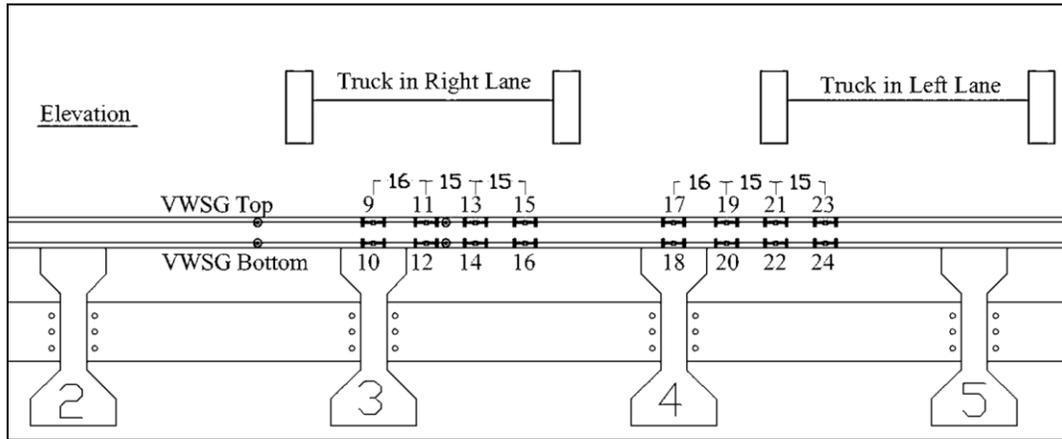
**Figure 15. Vibrating Wire Strain Gauge locations**

The VWSG were secured to the GFRP mats using zip ties and foam blocks and lie in the same horizontal plane as the GFRP mats, as shown in Figure 16. Each of the VWSGs has a built-in thermistor which records the temperature of the concrete in the panel. The maximum sampling rate for a VWSG is approximately 2 seconds and the sampling is carried out 1 sensor at a time.

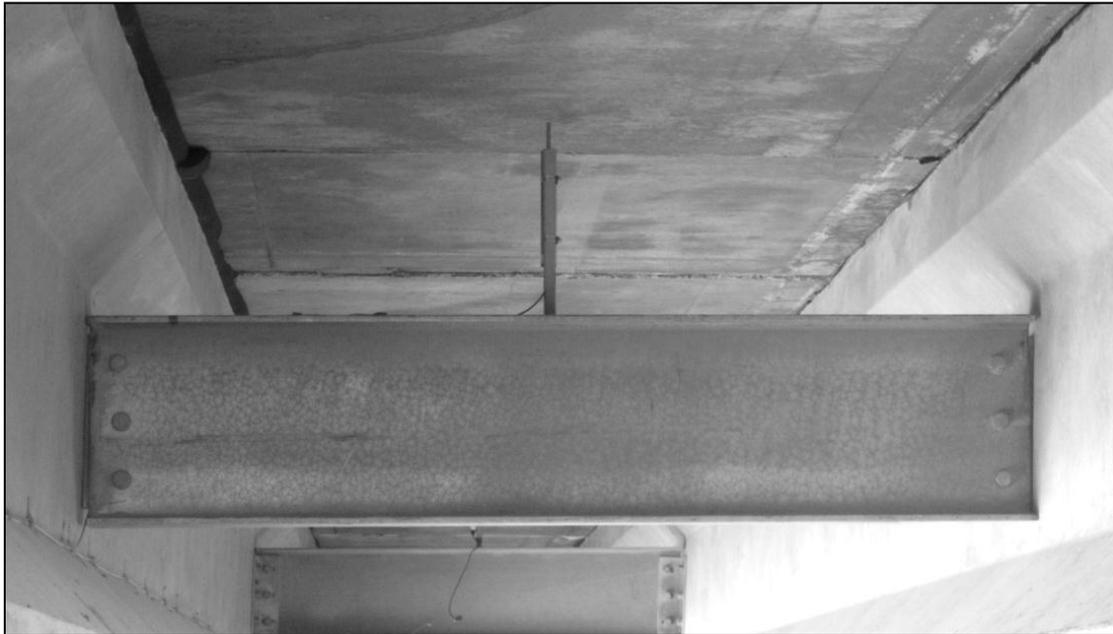
**Figure 17. Linear Variable Displacement Transducer attached to diaphragm under bridge**

The bridge was instrumented with 6 LVDTs. These sensors were placed on top of the diaphragms midway between the girders to measure the deflection of the deck relative to the girders. LVDTs #1-#5 were placed above the west diaphragm between girders 1 -6 respectively. LVDT #6 was placed between the second and third girder above the east diaphragm, directly across from LVDT #2. The LVDTs were attached to the diaphragms using hose clamps and a piece of square bar welded directly to the diaphragm, as shown in Figure 17.

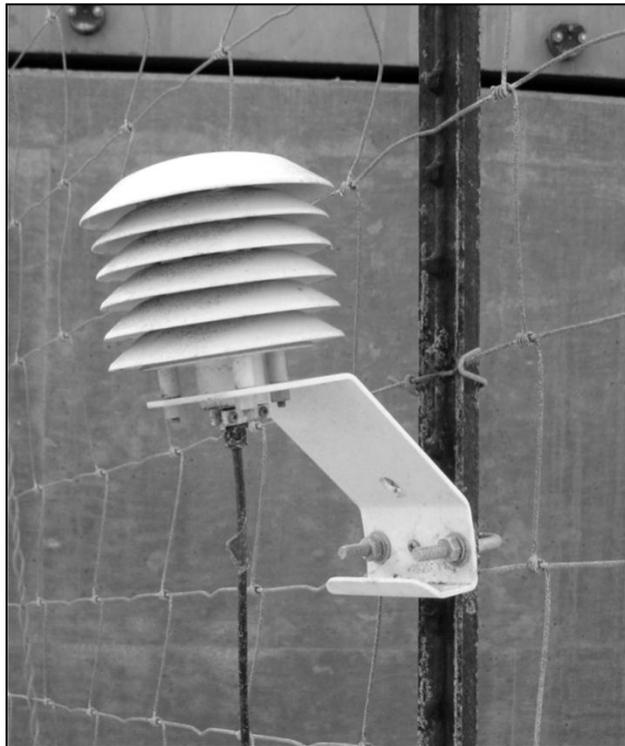
**Figure 18. HMP-50 in its protective housing attached to fence post adjacent to bridge**

Atmospheric data was collected using an HMP-50 sensor from Campbell Scientific. The sensor was mounted to a fence post adjacent to the bridge as shown in Figure 18. Data was averaged and recorded every 12 hours. The HMP-50 records both relative humidity as well as temperature. The accuracy of the relative humidity sensor is  $\pm 3\%$  (0% to 90% range) and  $\pm 5\%$  (90% to 98% range); the temperature sensor has a range of  $-40^{\circ}$  to  $+60^{\circ}\text{C}$  and is accurate to within 0.1 degree.

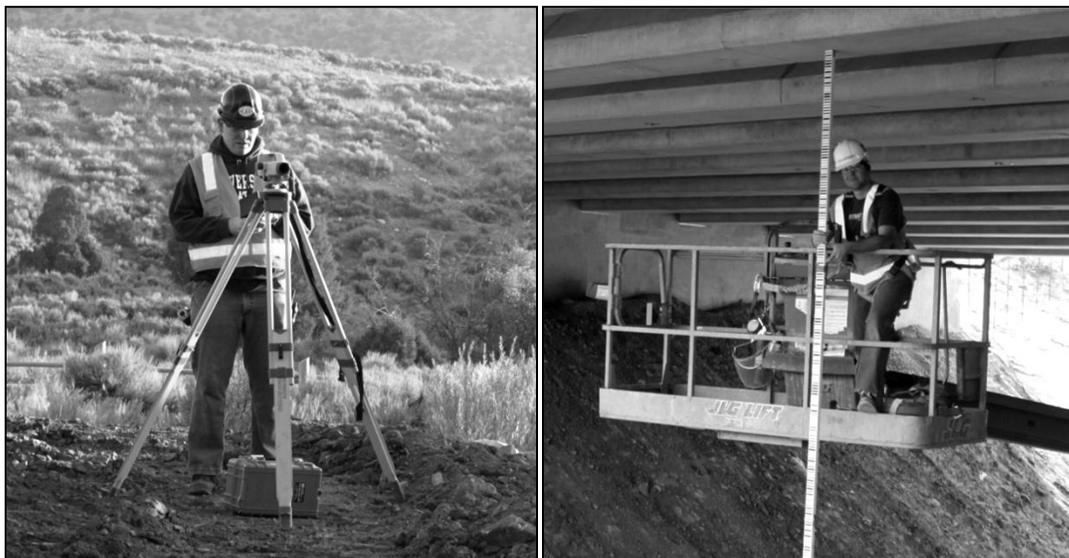
**Figure 19. Surveying team for truck load test**

In addition to the 5 types of sensors mentioned, surveying equipment was used to determine the midspan deflection of the 6 girders for each of the 9 static truck load tests. A Sokkia SLD30 power level was operated with a RAB (Random Bi-directional) code elevation staff to provide the deflections of the girders. The staff was held against the bottom of the girder by an operator in a JLG lift positioned under the bridge, as shown in Figure 19.

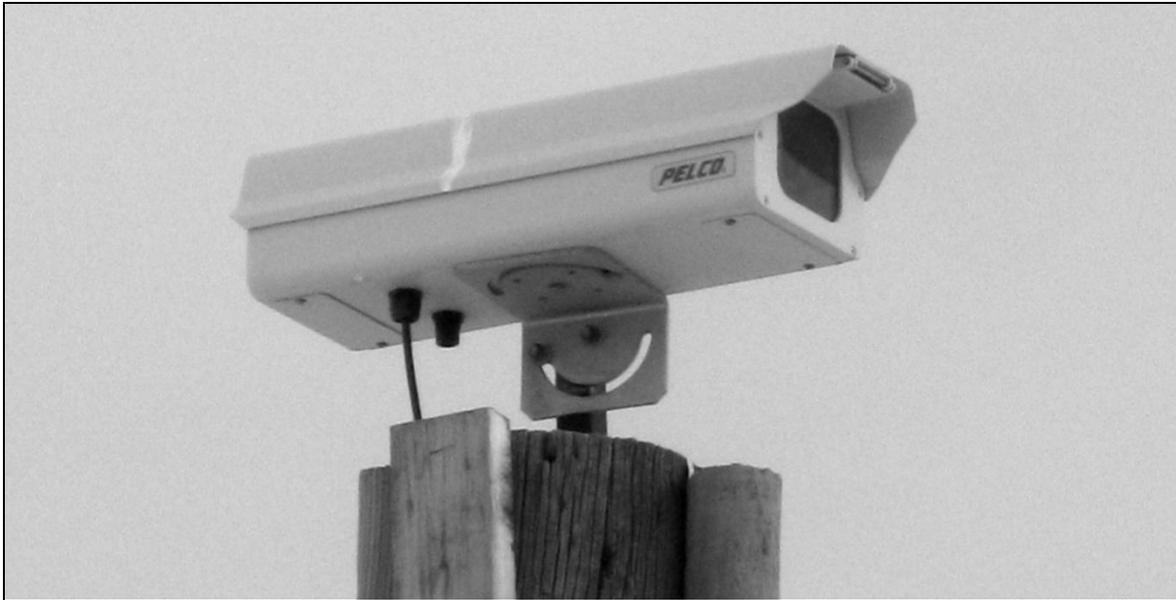
Figure 20. Still camera used for visual record of truck causing large accelerations

A still camera was aimed toward the bridge as shown in Figure 20; it was mounted on a 15'-0" post stationed approximately 30 feet north of the west abutment as shown in Figures 21-22. The purpose of the camera was to obtain a visual record of the truck that caused the largest accelerations. The camera is triggered whenever accelerometer #5 reaches a specific threshold of 0.025g.

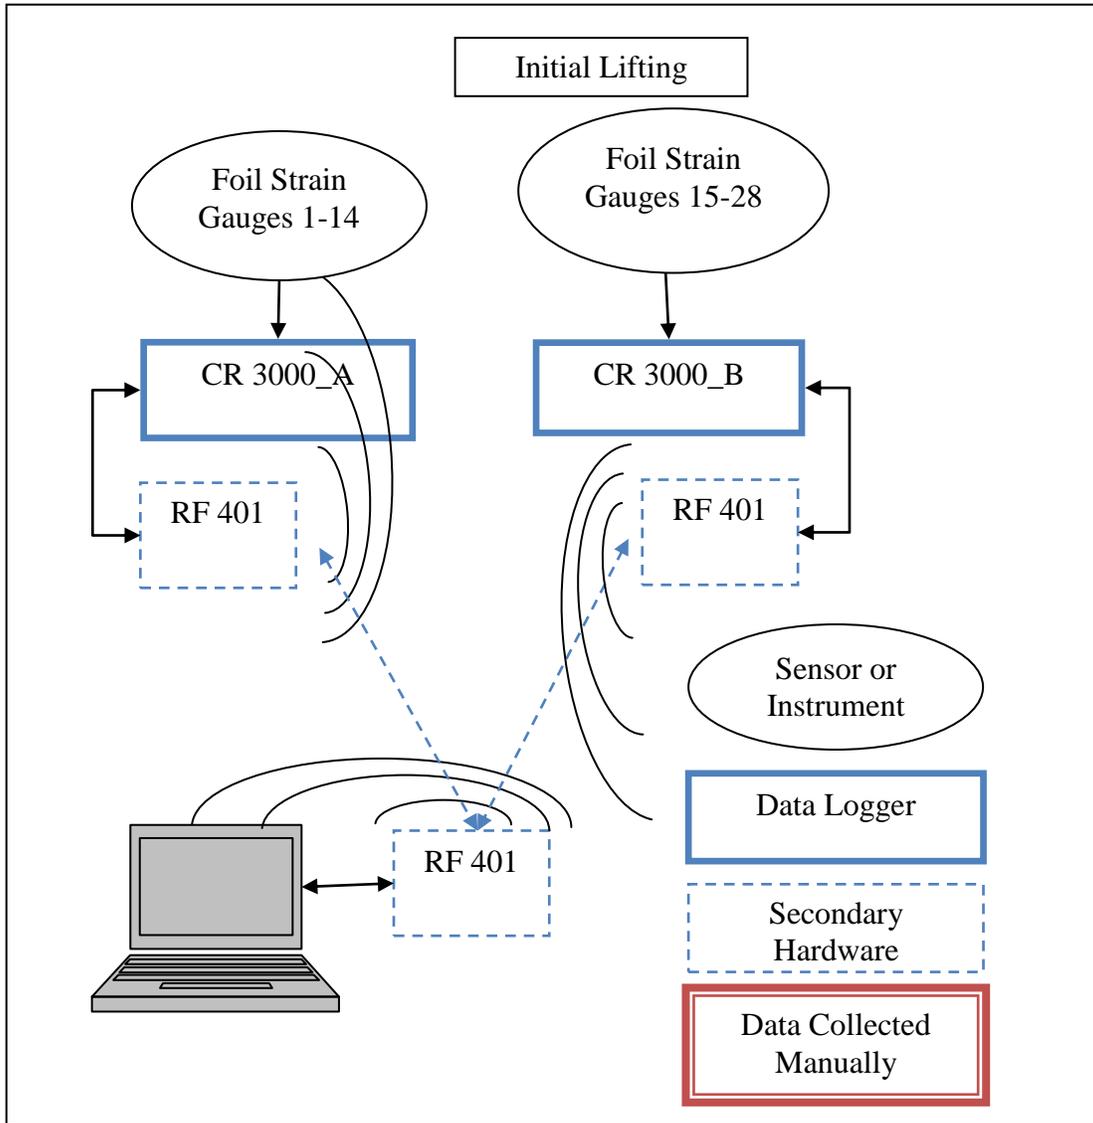
**Figure 23. Equipment setup for initial lifting**

Remote access is possible by using software on the laptop to communicate with the dataloggers. Many different Campbell Scientific software were used during this project. RT-DAQ was used for monitoring the lifting strains in real time due to its high refresh rate. Loggernet was used for accessing the dataloggers remotely, which provided access to download data tables, upload new programs for the dataloggers to run, monitor the bridge from offsite and manually trigger the camera. The program Ace Manager was used for configuring the camera. 2 programs were used for the compilation of data logger programs, Short Cuts and the CR Basic Editor. Lastly, a program called the Device Configurations utility was used to configure the dataloggers for use with all secondary hardware.

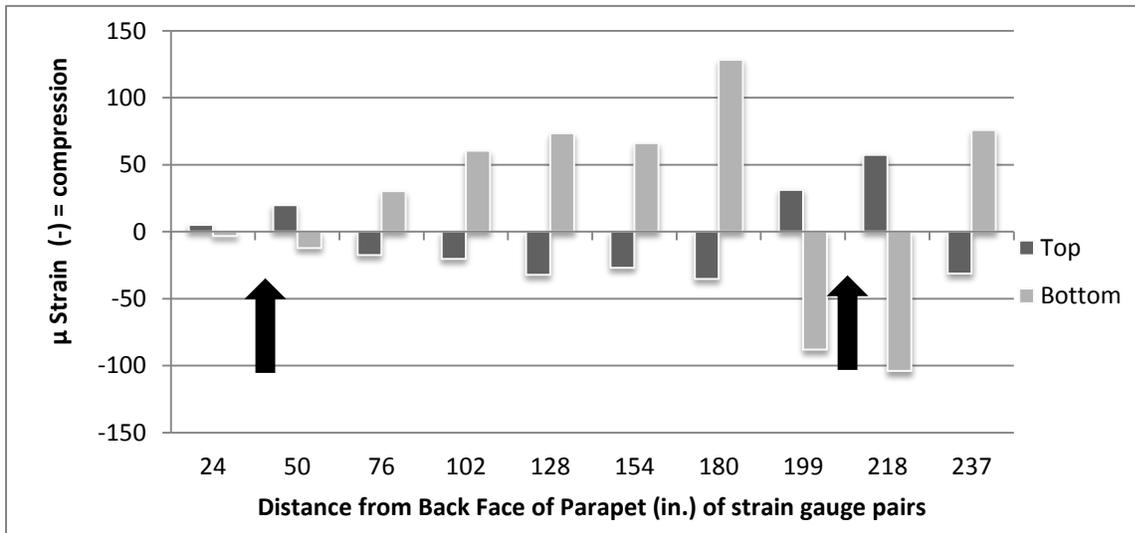
Figure 27. Strain profile for P2-05 during its first lift removing it from the formwork

Panels P2-05 and EP3, respectively were lifted on July 27<sup>th</sup> and August 6<sup>th</sup> 2009. The lifts occurred before the parapets had been cast. The panels were lifted from the formwork at 4 locations, as shown in Figure 10 (Lift 1). The maximum strain profile for half of the panel P2-05 is shown in Figure 27; one can observe that the maximum strain in the bottom mat is 125 microstrains ( $\mu\epsilon$ ) while the maximum strain in the top mat is 50 $\mu\epsilon$ . The lifting points are located at 46 inches and 202 inches from the left panel edge as shown in Figure 10 (Lift 1), and represented by arrows.

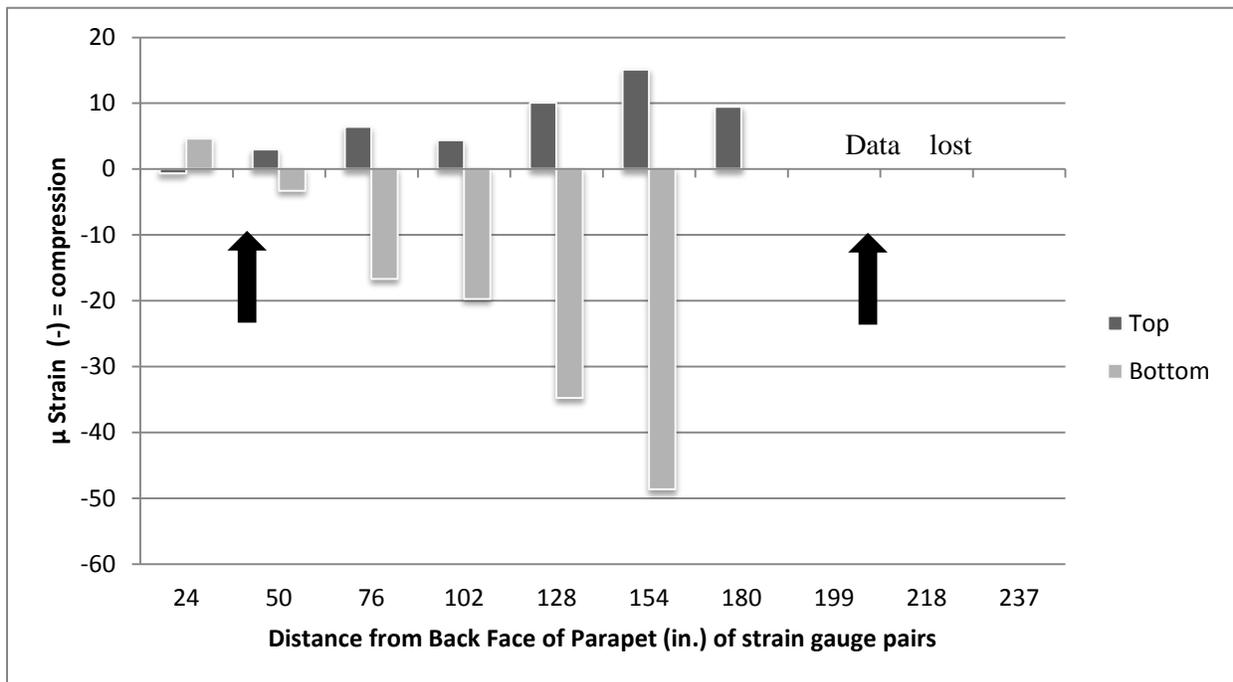
Figure 28. Strain profile for panel EP3 during its second lift

The panels were transported from the precaster to the bridge site on September 3<sup>rd</sup>, 2009. The transportation process involved 2 lifts (referred to as Lifts 2 and 3 as shown in Figure 10), and a 64 mile journey on a flatbed trailer. At this point the parapets on both panels had been cast. The collected data from this day is limited to the first 13 strain gauges from each panel. The maximum strain profile during the second lift for half the panel is shown in Figure 28. From the graph one can observe that the maximum strain in the bottom mat is  $-45 \mu\epsilon$  while the maximum strain in the top mat is approximately  $30 \mu\epsilon$ .

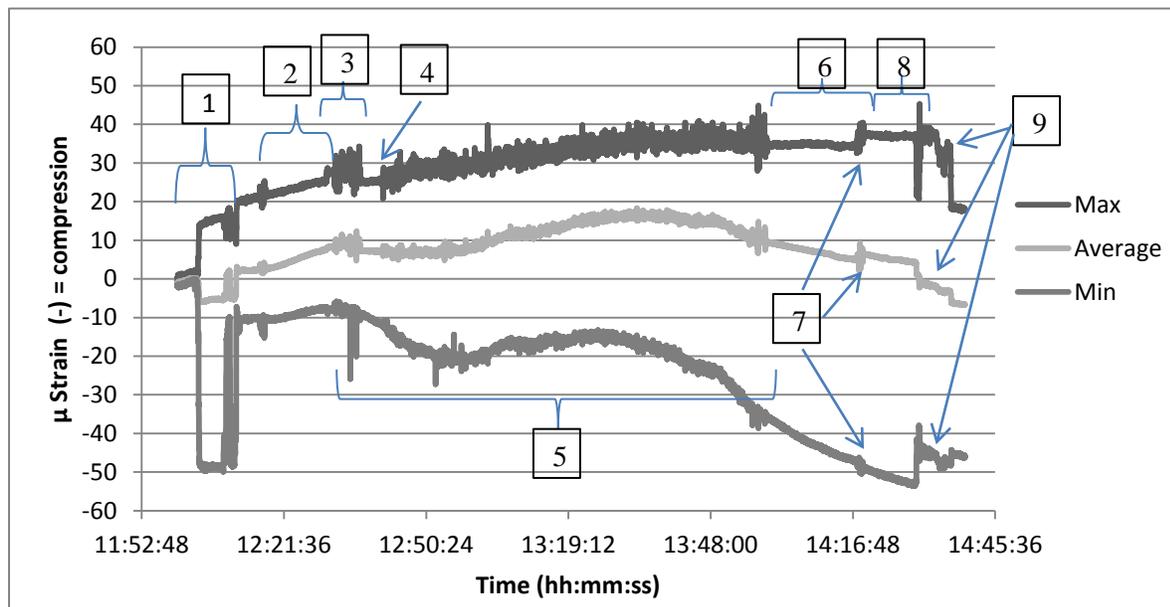
**Figure 29. Max, min, and average strain from all gauges during lifting and transport of panel EP3**

After the panels were placed on the trucks, the trucks began a 64 mile journey to the bridge site. The maximum, minimum, and average of all the strain gauges during the journey is shown in Figure 29. During transport of panel EP3 careful observations were made and correlated to the strains on the graph.

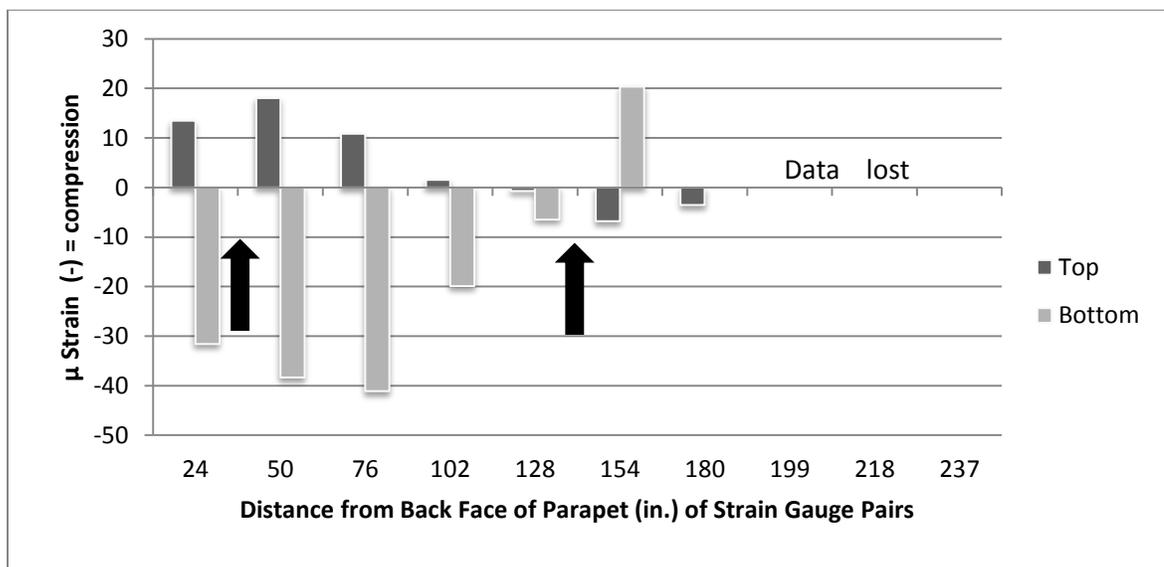
**Figure 30. Strain profile for EP3 during its third lift**

The maximum strain profile during the third lift is shown in Figure 30. The third lift occurred directly after the transportation of the panel to the bridge site; lifting points are shown in Figure 10. From the graph one can see that the maximum strain in the bottom mat is  $-45 \mu\epsilon$  while the maximum strain in the top mat is  $-35 \mu\epsilon$ . The strains for all 3 lifts never exceeded  $125 \mu\epsilon$ .

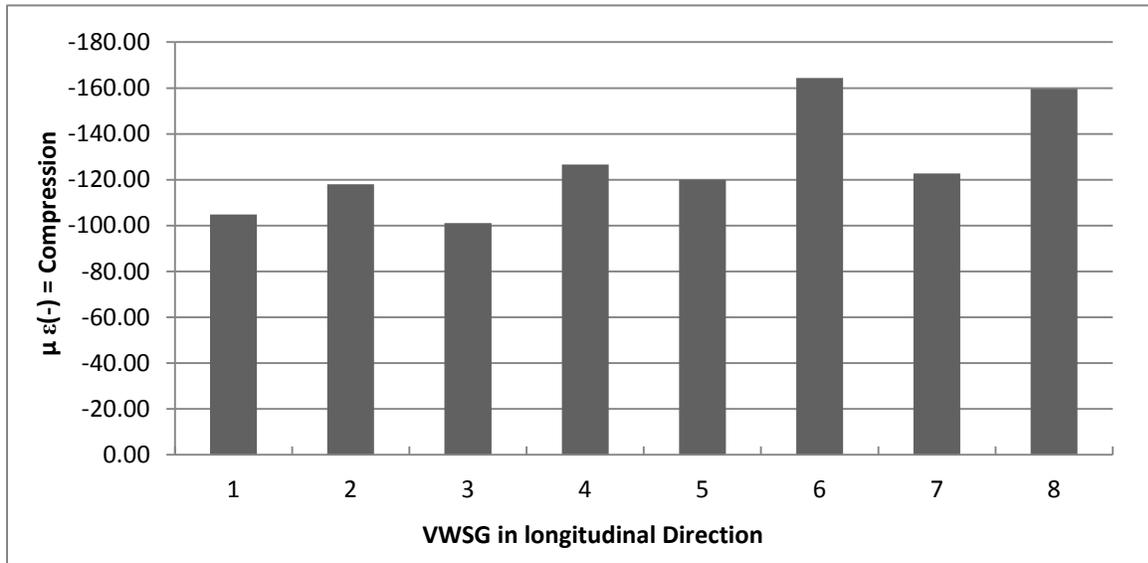
**Figure 31. Post tensioning strains in bridge deck**

The average concrete strain from all 8 gauges is approximately  $130 \mu\epsilon$  in compression. However, the average concrete strain for panel EP3 is  $112 \mu\epsilon$ , almost  $30 \mu\epsilon$  lower than those found in panel P2-05 where the average strain was  $141 \mu\epsilon$ . Approximately the same difference in

strain was found when comparing the averages of the top gauges to those of the bottom gauges. This difference is most likely due to the eccentric forces in the post-tensioning ducts. 3 tendons were used and eccentrically placed in the panel rather than the planned 4 tendons that could have been easier balanced.

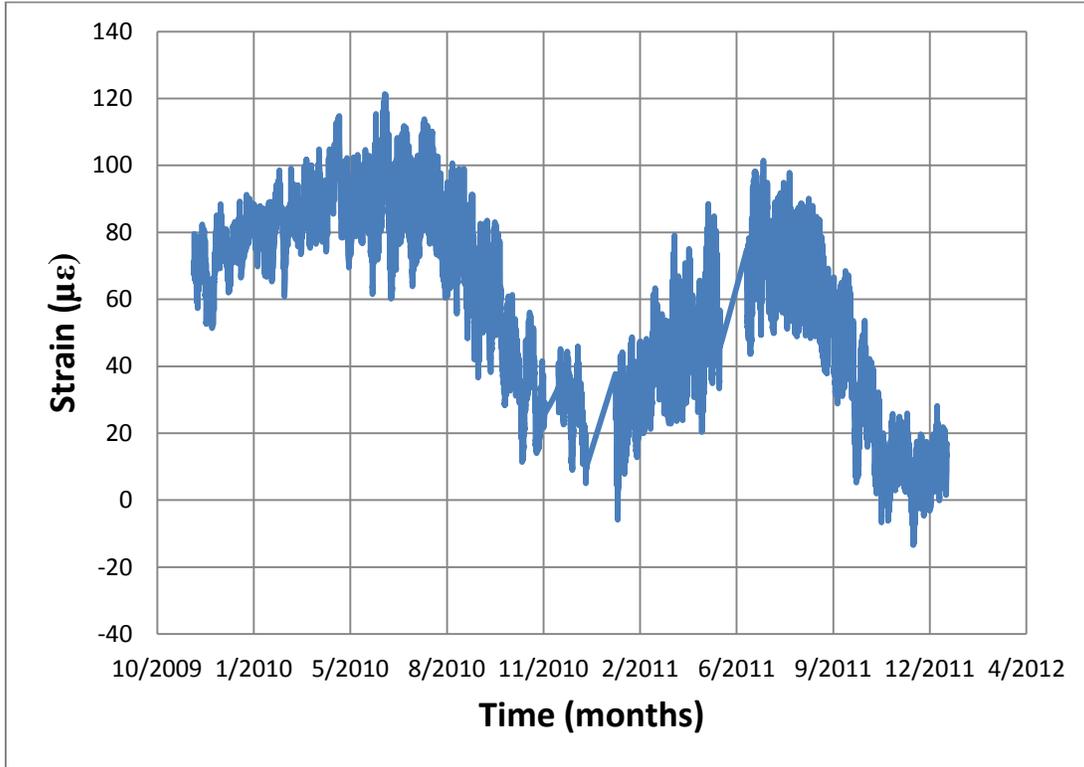
**Figure 33. Two-year concrete strain record**

The VWSG for long term monitoring have a mechanical component that measures the change in strain in the concrete and a temperature component that records the 24 hour diurnal strain from morning to night. These 2 components are combined in 1 output. Figure 33 shows a graphical representation of 2 years of true strain in the concrete for VWSG #2, located at the bottom mat of the bars.

within the limits of  $138 \mu\epsilon$  in tension at which concrete theoretically would crack and  $-3000 \mu\epsilon$  at which concrete fails in compression.

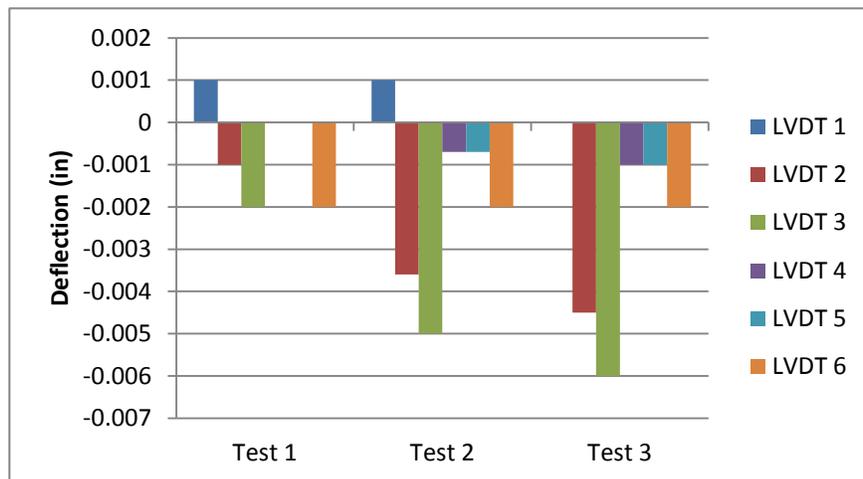
**Figure 34. Deck deflections from testing for Truck A, Sept. 29, 2009**

The September 29, 2009 static tests are separated into three groups depending on the lanes being loaded. Using Truck “A”, Tests 1-3 were performed on the slow lane; using truck “B”, tests 4-6 were performed on the fast lane; both trucks “A” and “B” were used in tests 7-9 in their respective lanes. These measurements were made using LVDTs at the east and west diaphragms as shown in Figure 21. The 3 tests for each case were obtained by centering the rear axle of the truck over the east diaphragm, midspan, and west diaphragm, respectively; the deck deflections from the 2009 tests are shown in Figures 34-36. These deflections represent the maximum relative movement of the deck with respect to the prestressed girders, at the diaphragm locations.

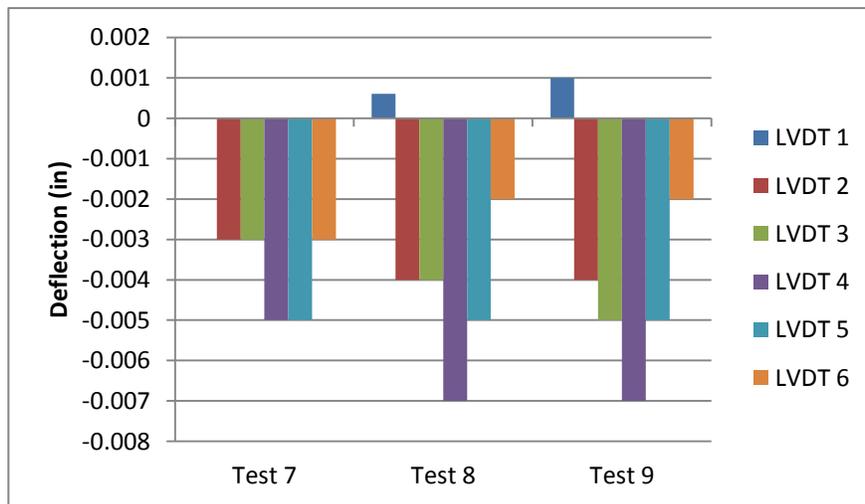
**Figure 36. Deck deflections from testing for Truck A and Truck B; Sept. 29, 2009**

From the September 29, 2009 tests, the highest relative deflections were found to be in the slow lane between girders 4 and 5 during Test 8 and Test 9, as shown in Figure 36; this is reasonable since both trucks “A” and “B” are located between midspan and the west diaphragm during Test 8 and are parked on the west diaphragm during Test 9. The magnitude of the relative deflection is very small, which shows that the bridge deck and girders have good composite

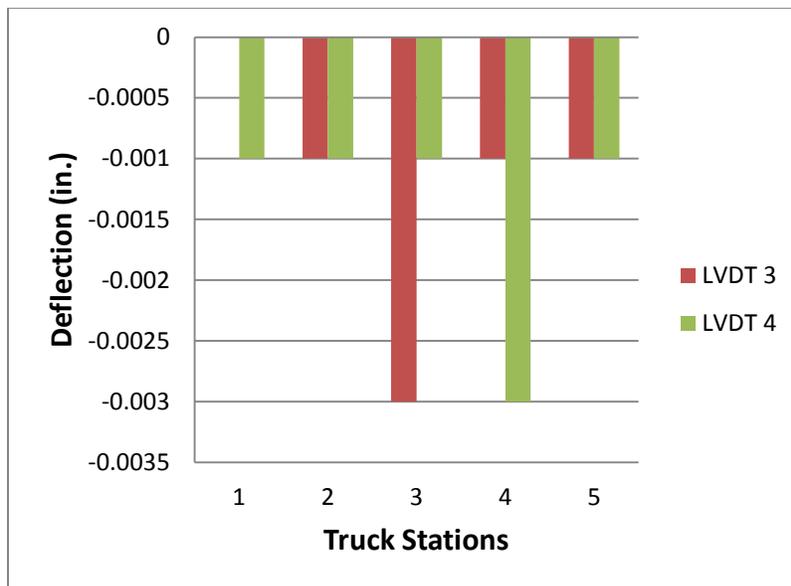
**Figure 37. Deck deflections from testing for Truck A and Truck B; Sept. 1, 2010**

The second truck load test was carried out on September 1, 2010. The truck weights for these tests are as follows: Truck “A” was 37.94 kips, Truck “B” was 45.68 kips. The deck deflections were very similar to results from the first truck load test with a maximum of 0.003 inches LVDT 3 and LVDT 4 are shown in Figure 37 for the case of both trucks “A” and “B” being on the bridge deck. Other LVDT’s read 0.001 inches or below.

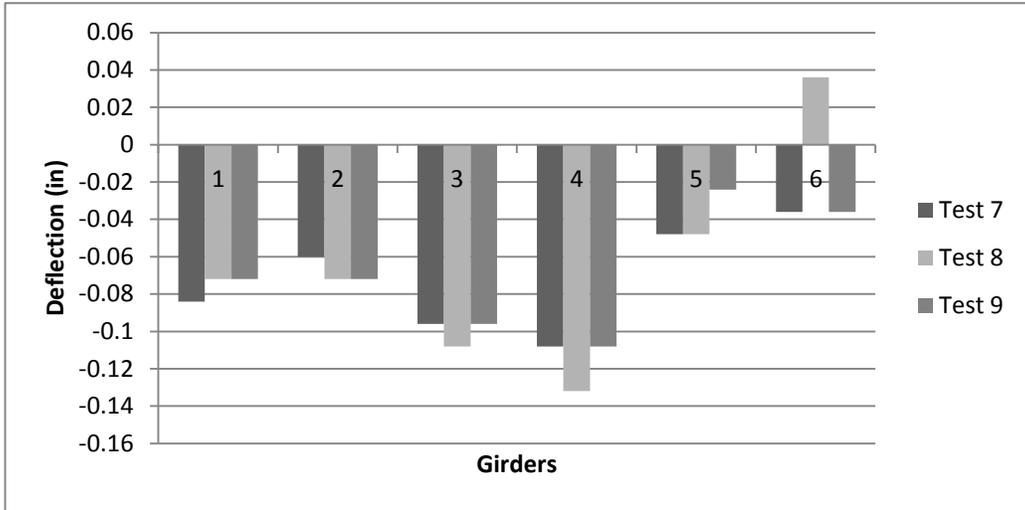
**Figure 38. Midspan girder deflections for tests 7 through 9 for Girder #4**

As expected, the maximum deflection of the girders occurred during Truck Load Test #8 on September 29, 2009 when both trucks were parked at the bridge midspan. The maximum deflection was 0.13 inches as shown in Figure 38, recorded in girder 4 located between the 2 trucks. The peak deflection recorded was 0.13 inches which is well below the AASHTO limit of  $L/800$ , or in this case 1.32 inches All girder deflections were measured with survey equipment; the uplift in girder 6 is due to operational human error while collecting survey data.

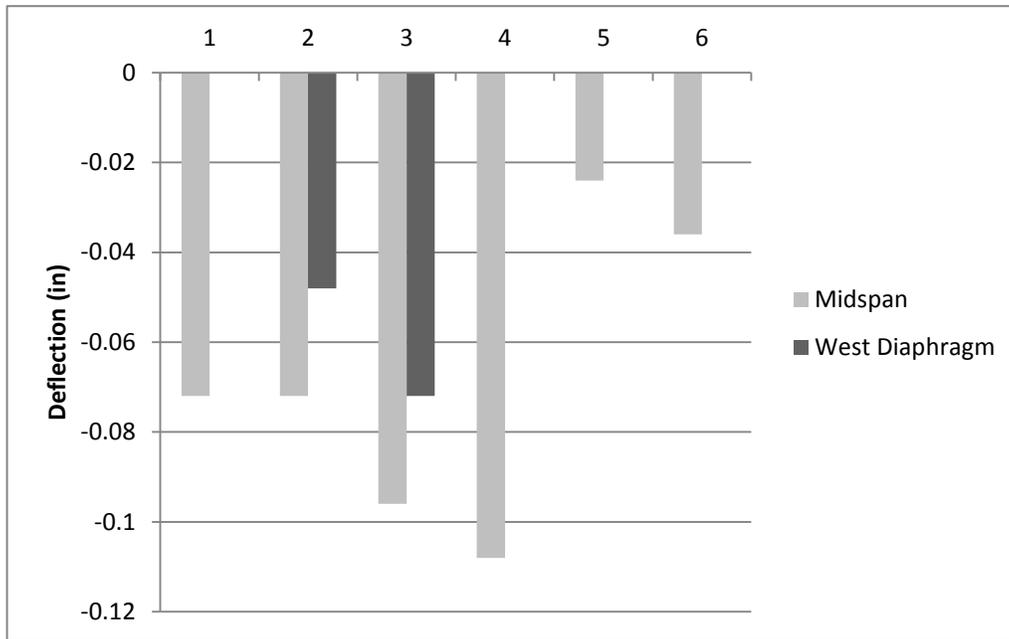
**Figure 39. Girder deflections for truck load test 9**

During truck load test 9, additional girder displacements were measured above the west diaphragm. This was done to correlate girder deflections and panel deflections at the same point. Additional deflection data was taken for girders 2 and 3, as shown in Figure 39. The deflection of the diaphragm is assumed to be linear between the girders. The displacement of the diaphragm at midspan between girders 2 and 3 was calculated to be 0.06 inches. Combining this with the panel deflection from LVDT #2 for the same test, the total deflection of the panel located above LVDT #2 has been calculated to be 0.064 inches. The relative deflection of the panel with respect to the least deflected girder can be determined using half the difference between the 2 girders and deflection data from LVDT #2. This results in a deflection of 0.016 inches relative to girder 3. Both of these values are below the AASHTO limit of 0.101 inches.

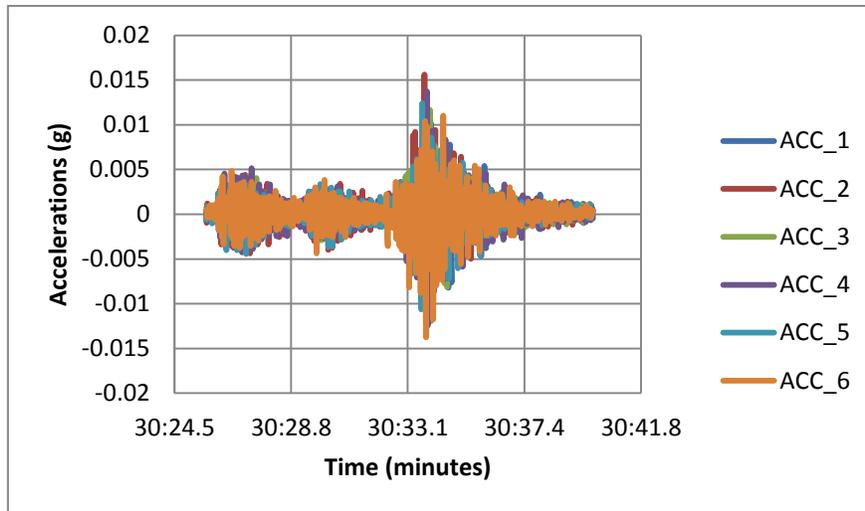
**Figure 40. Acceleration record for truck B traveling at 40 mph for Test 1**

Dynamic truck load tests were also performed on September 29, 2009 before the bridge opened to traffic and consisted of 5 tests. The 6 accelerometers are attached to the bottom of the flanges at midspan of the girders, as shown in Figure 21; all 6 accelerometers measured data as shown in Figure 40. Accelerations measured at the midspan of the prestressed girders for the 43.16 kips “B” truck traveling in the fast lane at 40 mph, showed that the maximum vertical acceleration recorded during this test was 0.015g (Test 1 in Figure 41). By comparison, the maximum acceleration for the case of 65 mph recorded was 0.026g in girder 2 (Test 2 in Figure 42).

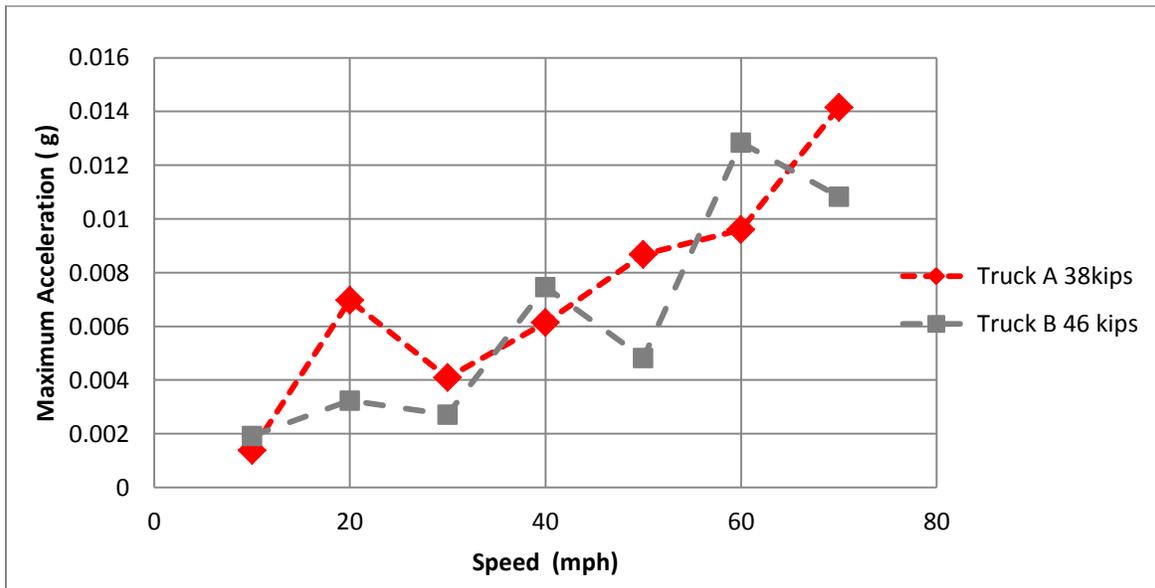
**Figure 43. Maximum accelerations from second truck load test performed Sept. 1, 2010, as a function of truck speed**

Dynamic truck load tests carried out during the second truck load test of September 1, 2010 with trucks weights “A” of 37.94 kips and “B” of 45.68 kips showed that the maximum overall vertical acceleration recorded during this test was 0.014 g, as shown in Figure 43.

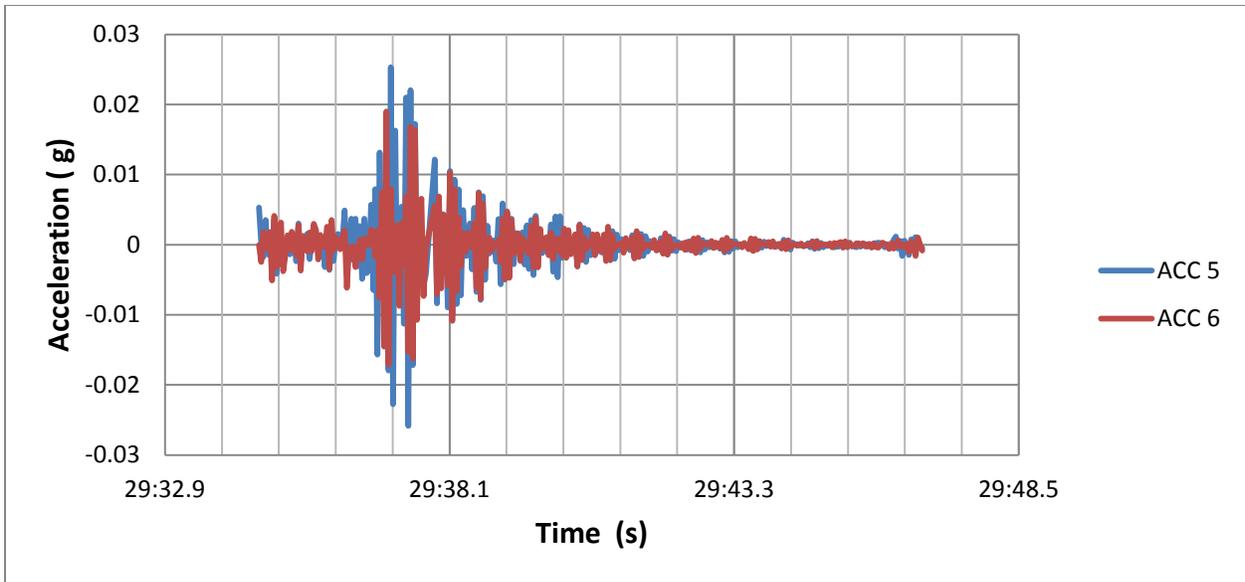
**Figure 45. Acceleration record of Oct. 22, 2010 during a construction period**

Truck load tests were carried out in a controlled environment, in which the weather conditions were good, and the weight and speed of the truck were known. However, some of the higher acceleration data measured from long term monitoring comes from continuous monitoring and capturing “snapshots” of real life conditions at the bridge. The data and picture below in Figures 45-46 are a representation of such events.
